United States Environmental Protection Agency
Washington, D.C. 20460
Water Compliance Inspection Report

AES PUERTO RICO, L.P.

Coal-Fired Steam Power Plant

**Enforcement Case Support Inspection Report
Industrial Site Inspection**

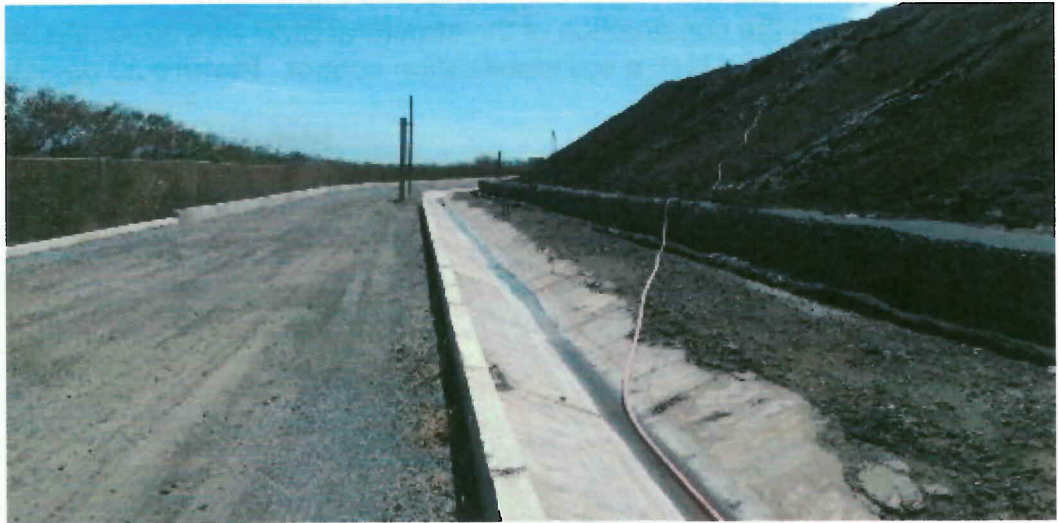
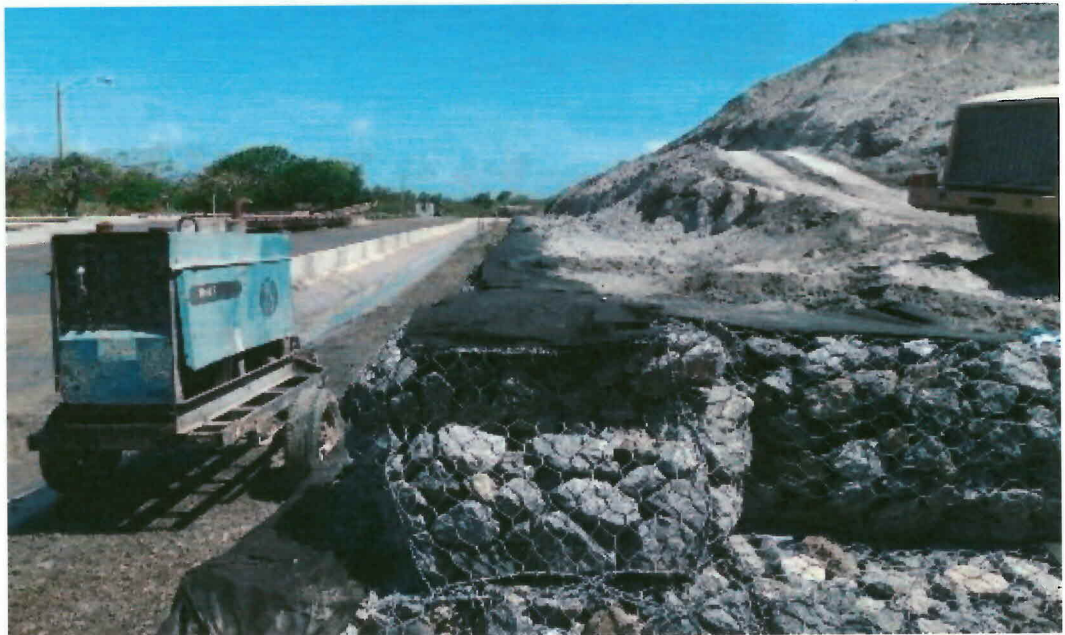
- 1) **Finding:** Certain slope bottoms of the Aggremax™ storage pile were observed on top of the gabion BMP structure, precluding this designed BMP (and its attached silt fence) to function as a storm water filtering system. The EPA Inspectors also observed AES personnel using mechanical equipment to remove Aggremax™ away from the gabions to allow space for the required buffer area. **Pictures 31-32** depict this finding.

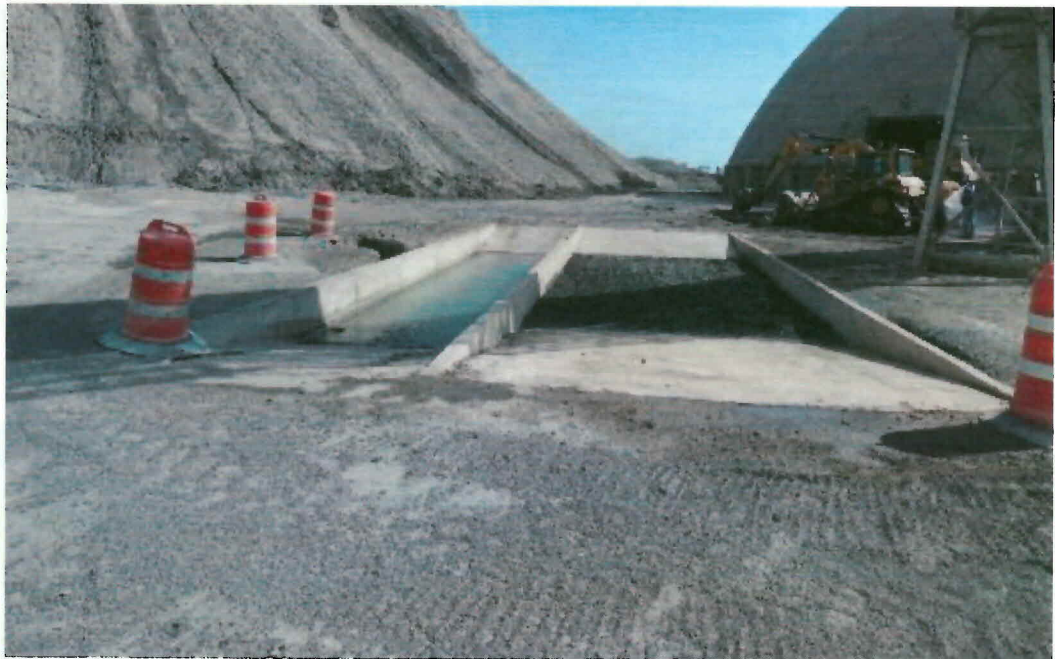
Picture 33

- 1) **Finding:** AES constructed a structural BMP between the Aggremax™ storage pile and the limestone storage dome, which serves as reduce of site tracking of sediments into Plant roads. The EPA Inspectors found that the construction of the structural BMP was adequate but the exit path to the road lack a soil stabilization control. **Picture 33** depicts this finding.

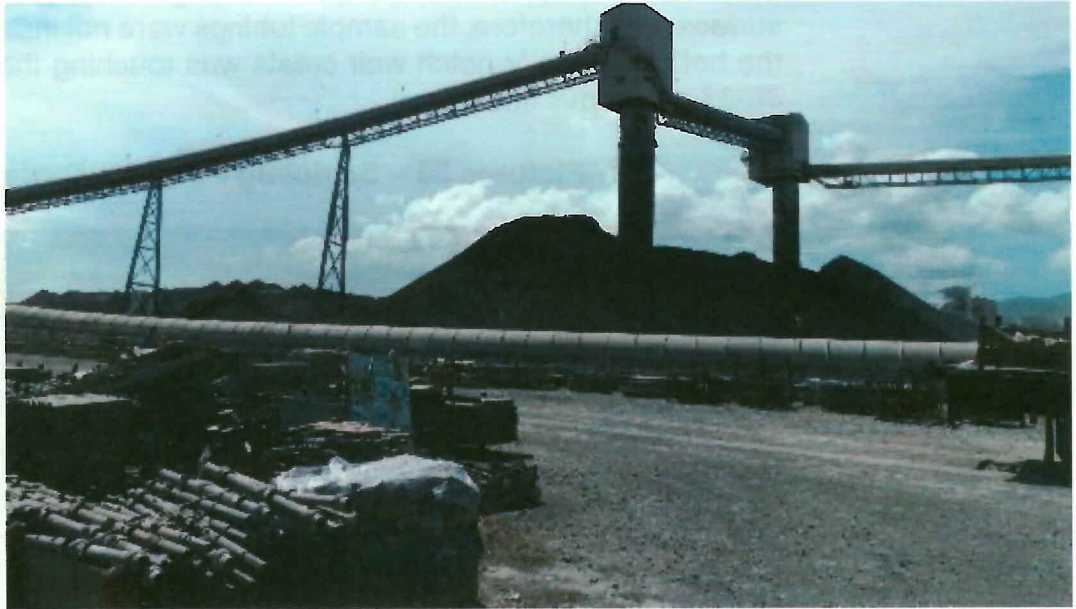
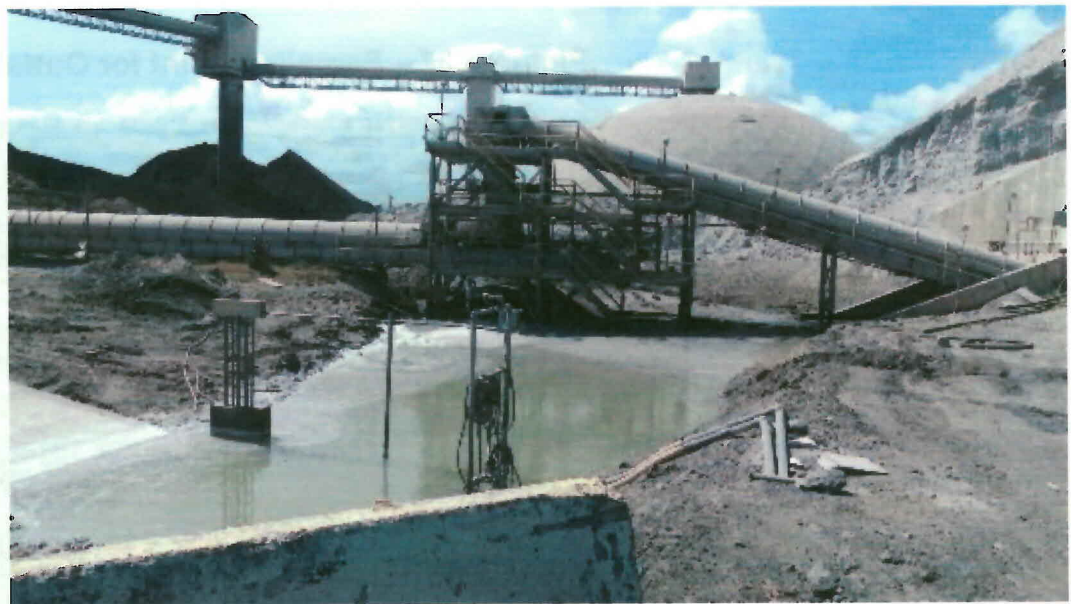
- 2) **Finding:** The plant yards behind the south side of the limestone storage dome were observed without soil stabilization. Also, the process wastewater basin located in this area was not constructed following best engineering practices to allow for adequate sedimentation and slope stabilization. **Pictures 34-35** depict this finding.

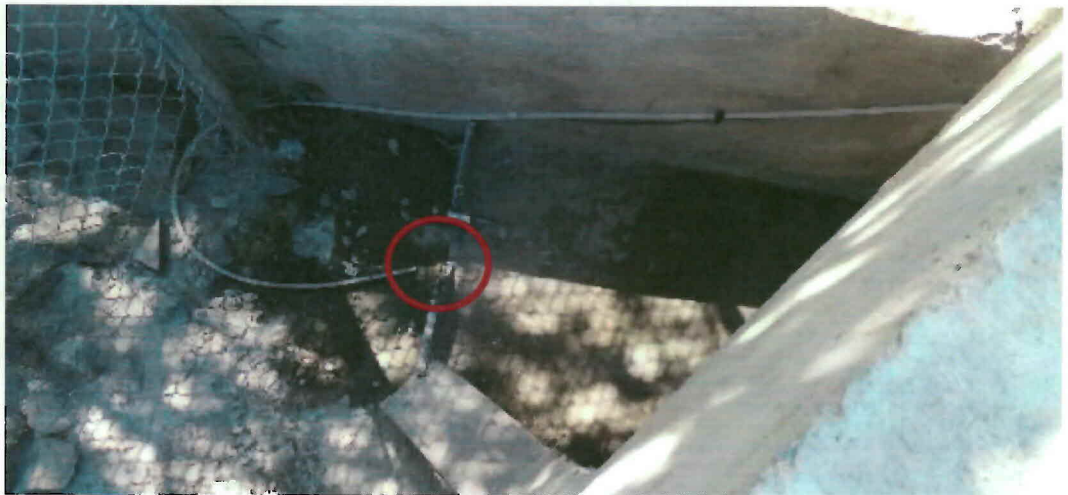
Pictures 36 – Sampling Point for Outfall 002

- 1) **Finding:** AES installed two (2) V-notch weirs to provide for a free and unobstructed flow when sampling the storm water discharges associated with industrial activity through outfalls 002 and 003. AES also installed two

(2) solar-powered automatic samplers for sampling points 002 and 003. However, the tip of the samplers tubings was observed touching the surface; and therefore, the sample tubings were not installed properly. Also, the bottom of the V-notch weir crests was touching the surface. **Pictures 36-37** depict this finding.

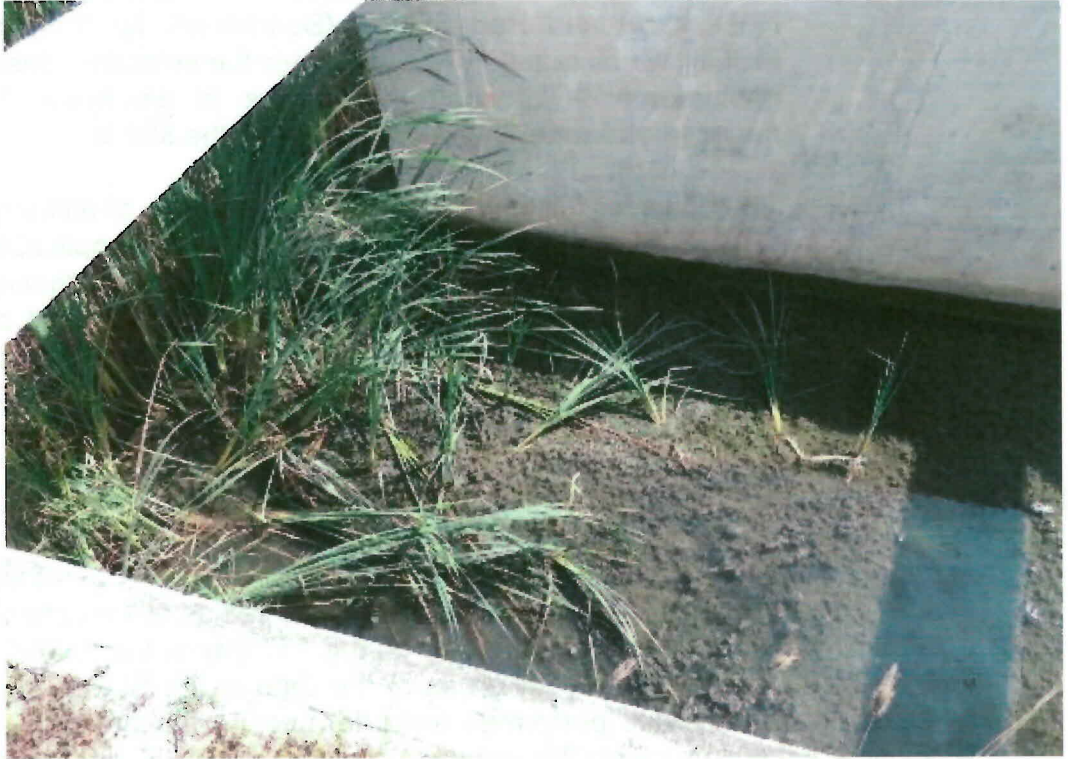
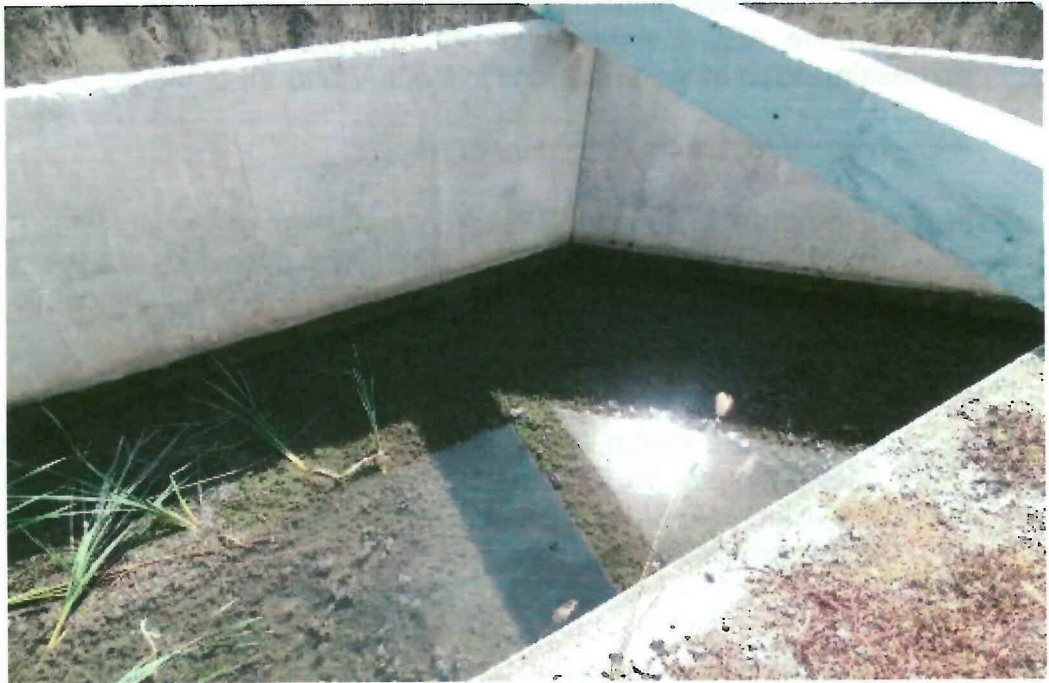
- 2) **Finding:** The EPA Inspectors observed vegetation growth and lack of maintenance along the concrete channel that discharges through Outfall 003. This is causing unnecessary backflow and algae growth. **Pictures 38-39** depict this finding.

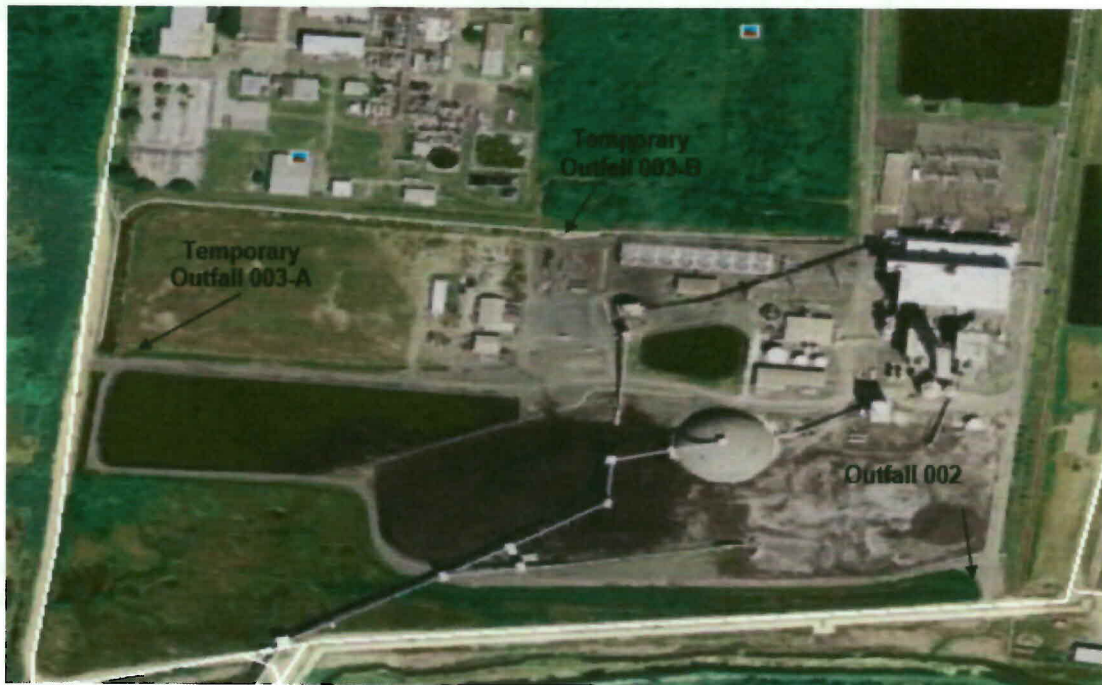
Figures 9 and 10 show the approximate location of the interim sampling points and the permanent sampling points.

Figure 9
Location of SP-002, SP-003A, and SP-003B

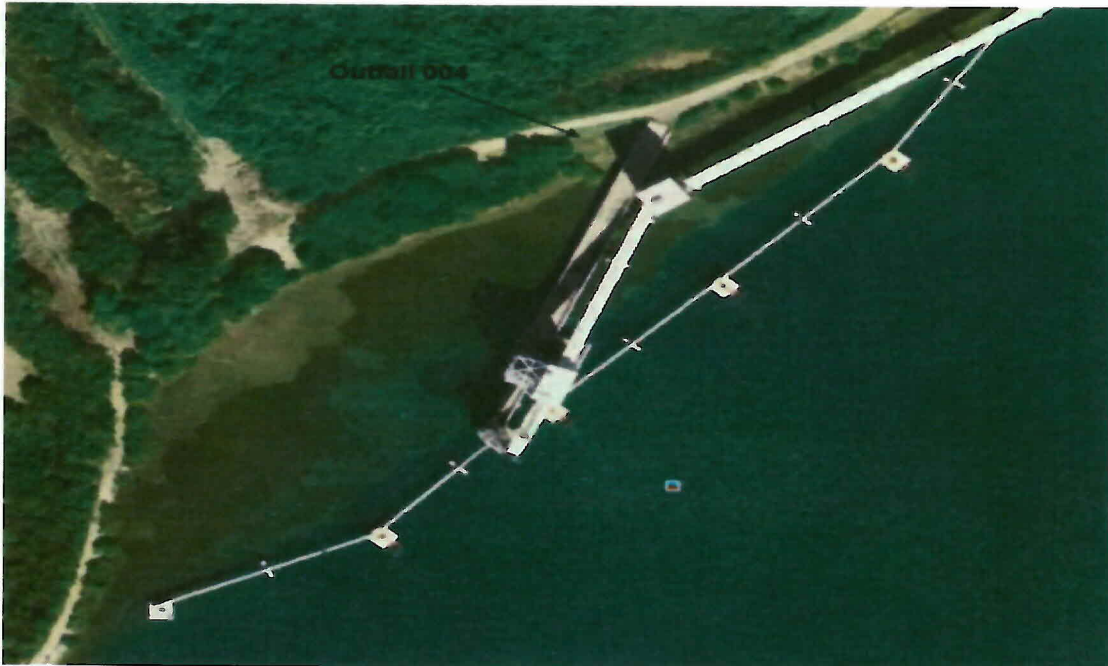
Figure 10
Location of SP-004
